Student Name: ██████████	Year of Course: Year 1
Evidence Type: Module Job Description: Investigate and find leak within pressurised tank using thermography	Module: Modern Engineering Practice Module No: M1H326682
Competence Description (from GA UK_Spec Map): Select and apply appropriate materials, equipment, engineering technologies and processes, recognising their limitations	UK Spec Ref Code: C13
<p>Provide a description of the activity (to be) carried out: (Reference: Documents / Drawings used / H&S / Safe Access / PPE / Tools and Equipment / Materials)</p> <p>This week I needed to identify any present leaks on Blend Tank 3 using thermography.</p> <p>The Activity: (Reference Hand Over Procedures / Restoring the Workplace)</p> <p>Prior to the yearly insurance inspection of our on site blend tanks, it is common practice to pressurise the tanks to 63 psi with water and compressed air ensuring the pressure holds. The tank began to drop in pressure and evidence of water was present at the bottom of the tank, therefore an investigation to find these leaks had to be carried out. As the tank is insulated, it is difficult to pinpoint exactly where the leak is escaping, so using the therm

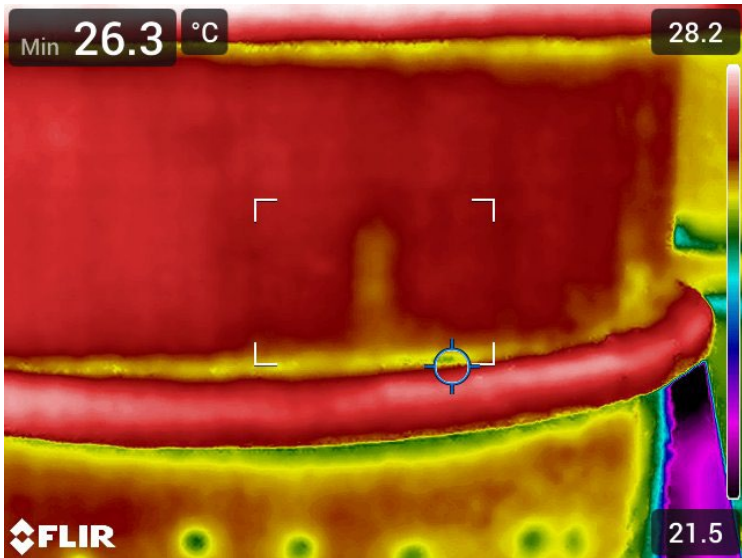
Figure 1 - FLIR image of the blend tank

tank, where it quickly became evident that there was a large damp area surrounding a weld. The area was wiped dry which exposed a small pin hole on the weld, this would be the area that impacted the pressure of the tank. Contractors were then arranged to repair the pin hole who removed a section of the tank and re-welded the area after draining the tank. Once complete, the tank was then refilled with water and pressurised back to 63 psi. After a few hours of successfully holding pressure, and no water was evident around the tank, the tank was then ready for the insurance inspection which was due to be carried out the following week.
