| <b>Evidence Type:</b> Module | <b>Module:</b> Modern Engineering Practice |
| <b>Job Description:</b> Investigate and find leak within pressurised tank using thermography | <b>Module No:</b> M1H326682 |

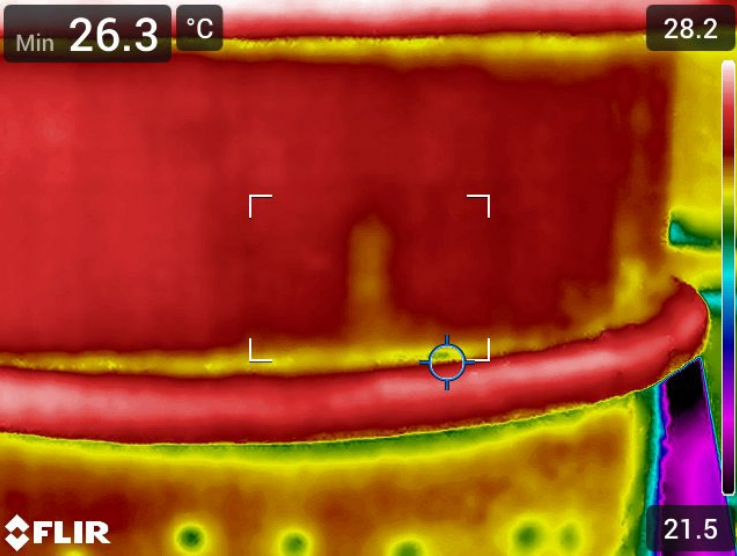
| <p>Figure 1 - FLIR image of the blend tank</p> <p>tank, where it quickly became evident that there was a large damp area surrounding a weld. The area was wiped dry which exposed a small pin hole on the weld, this would be the area that impacted the pressure of the tank. Contractors were then arranged to repair the pin hole who removed a section of the tank and re-welded the area after draining the tank. Once complete, the tank was then refilled with water and pressurised back to 63 psi. After a few hours of successfully holding pressure, and no water was evident around the tank, the tank was then ready for the insurance inspection which was due to be carried out the following week.</p> | |
