REMEDIATION VALIDATION REPORT

58 Renfrew Street
Glasgow
G2 3BW

J18065

Consideration is being given to the construction of a 13-storey to 15-storey hotel and a 16-storey block of student accommodation, along with two areas of soft landscaped amenity space. The site has previously been subject to a desk study and ground investigation by GEA (Report Ref J18065, dated 30 May 2018). The previous work identified fragments of asbestos within the shallow made ground and, at a single location, elevated TPH, PAH and phenol concentrations were measured.

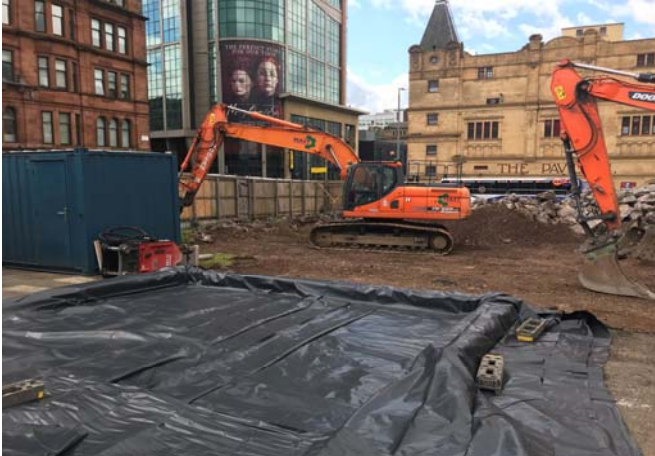
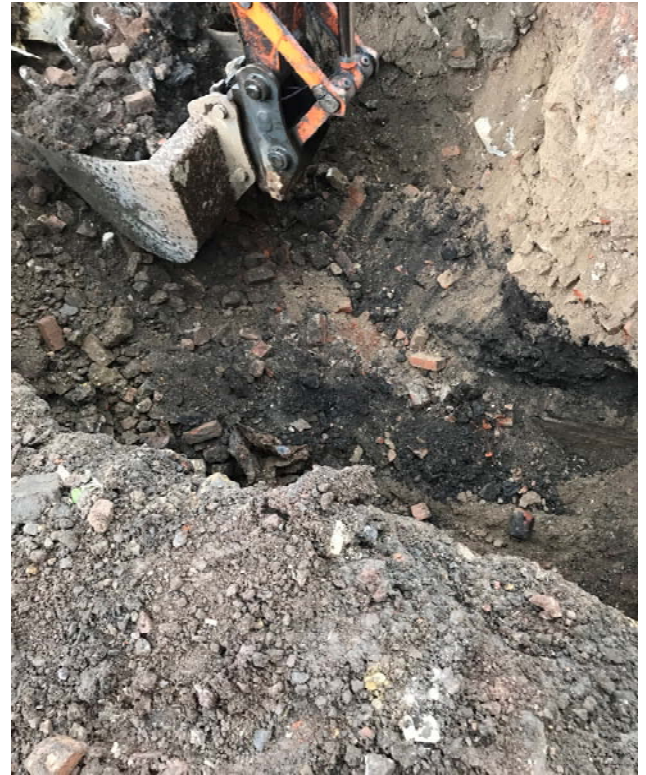
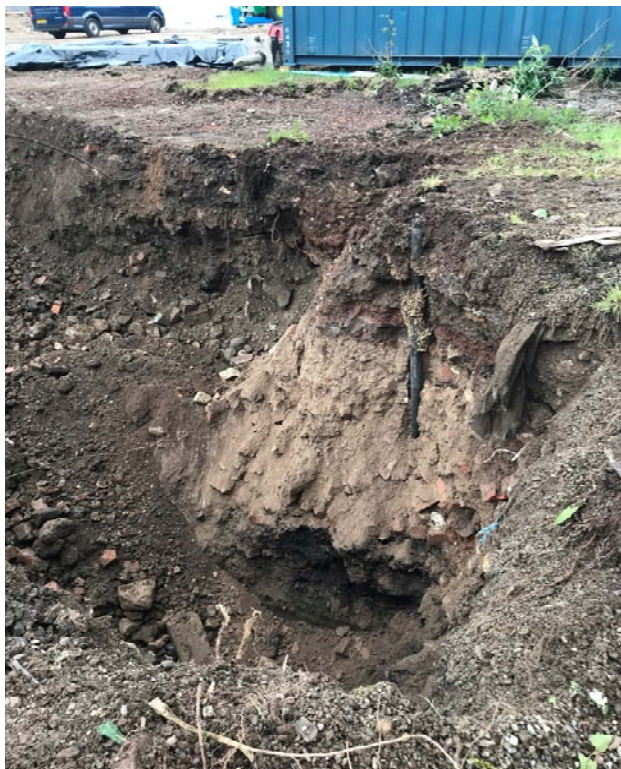
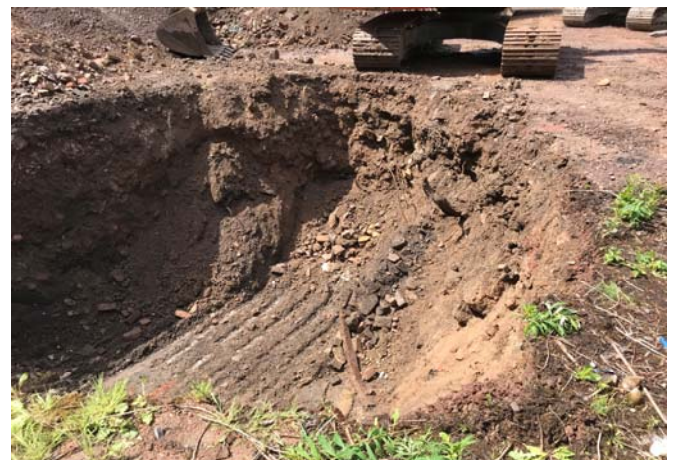
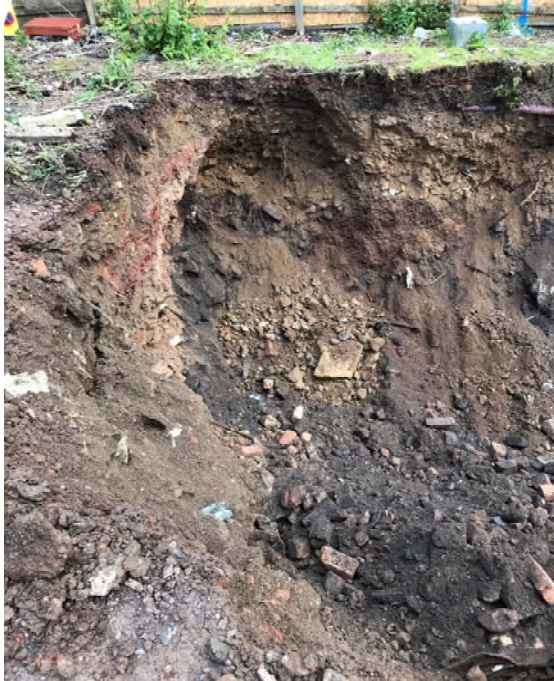
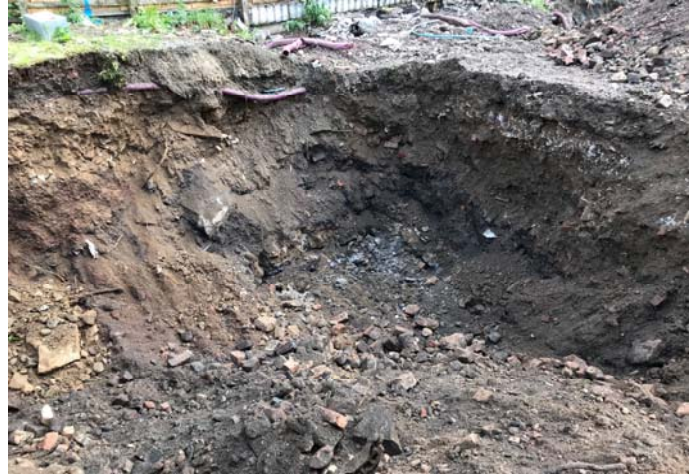
On 28th May 2019, GEA reported to site to direct the excavation of the coal tar. The excavation commenced south of Borehole No 6 using a 20 tonne excavator and 1.2 m wide bucket. The excavation revealed coal tar at a depth of 2.8 m in solid form with fragments of up to 300 mm x 150 mm x 75 mm thick. Whilst odorous, this material was not volatile and no concentrations above background levels were recorded on the

PID. The coal tar was black in colour and easily identifiable by its odour and nature as being different from the surrounding soil and these two parameters were used to determine the extent of the excavation. The excavation was extended in all directions and to a maximum depth of 3.2 m until to north south and west until the material had been removed. The extent of the excavation was surveyed and a plan showing its location is appended.

Plans and photographs showing the extent of the excavation.
